**DEPARTMENT OF PUBLIC WORKS GUIDELINES
For the Placement of Barricades at Construction Sites
ORDER NO. 167,840**

EXAMPLES OF CORRECT AND INCORRECT BARRICADING METHODS

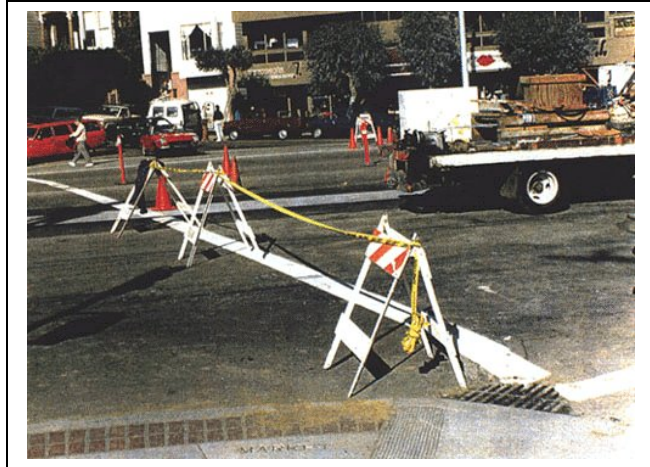
A. Incorrect Barricading Method

- "A-Frame" spacing is too wide
- Caution tape does not provide an adequate barricade or detectable path-of-travel
- Curb cut access has been blocked

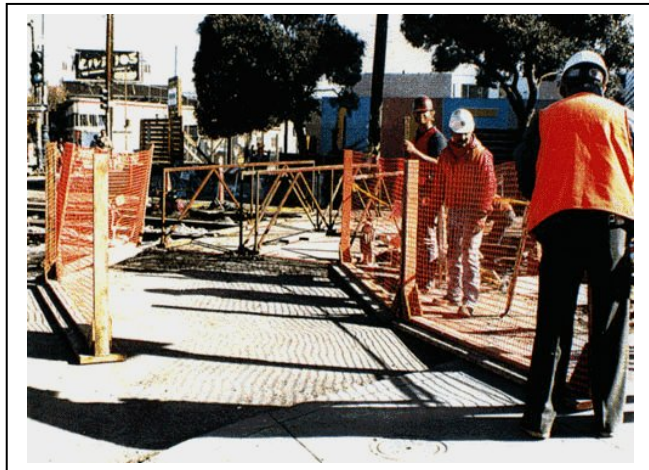
B. Correct Barricading Method

- Orange plastic fencing with baseboard provides an easily detectable path-of-travel for persons who are blind/low visioned and using a "white mobility cane" Baseboard will also help eliminate the potential for a person using a "white cane" from getting the cane caught in the fencing mesh.
- Temporary bridging system (wooden decks/steel plates) provides an accessible path-of-travel for persons using a wheelchair. (Note: the cold patch (asphalt) at the ends of the bridge provides a beveled 1:2 lip of no more than 1/2 inch for a smooth transition).

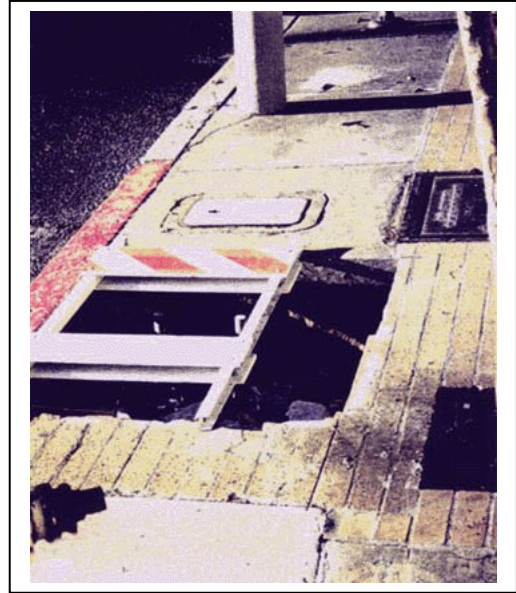
E. Incorrect Barricading Method

- This is an open trench/pit, for a new light pole. An opening in the path-of-travel poses a severe hazard to able bodied pedestrians as well as disabled pedestrians.
- The perimeter should be completely blocked off with upright barricades and no spacing should exist between the barricades.
